LEATHERWOOD CREEK NO. 5

HENRY COUNTY, VIRGINIA

# PHASE I INSPECTION REPORT

## NATIONAL DAM SAFETY PROGRAM

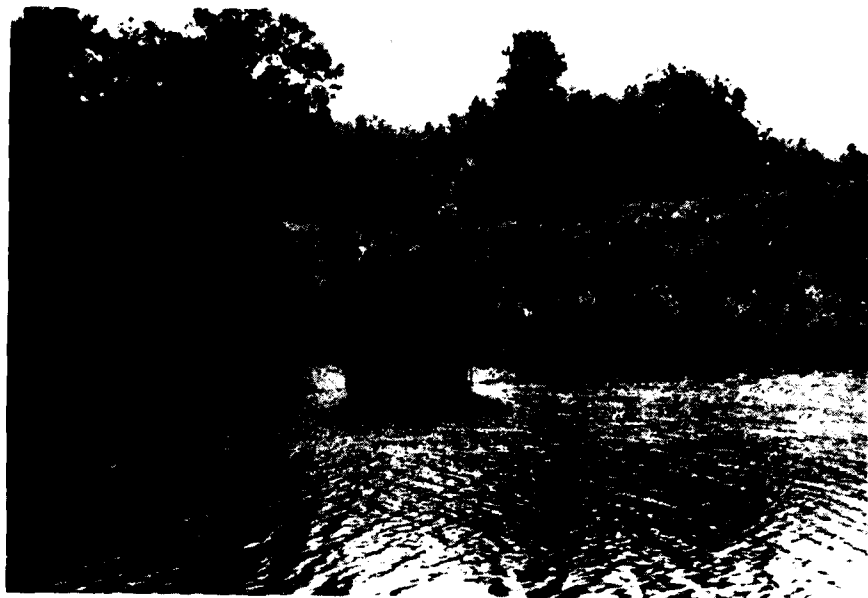
Photograph No. 3 - Intake Structure

The riser structure and outlet pipe showed no signs of deterioration and were functioning properly at the time of inspection. Debris was not present in the low level intake trash rack. The plunge pool and outlet channel indicated no signs of deterioration. The emergency spillway was well vegetated except for some minor erosion due to several cattle paths and vehicle traffic.

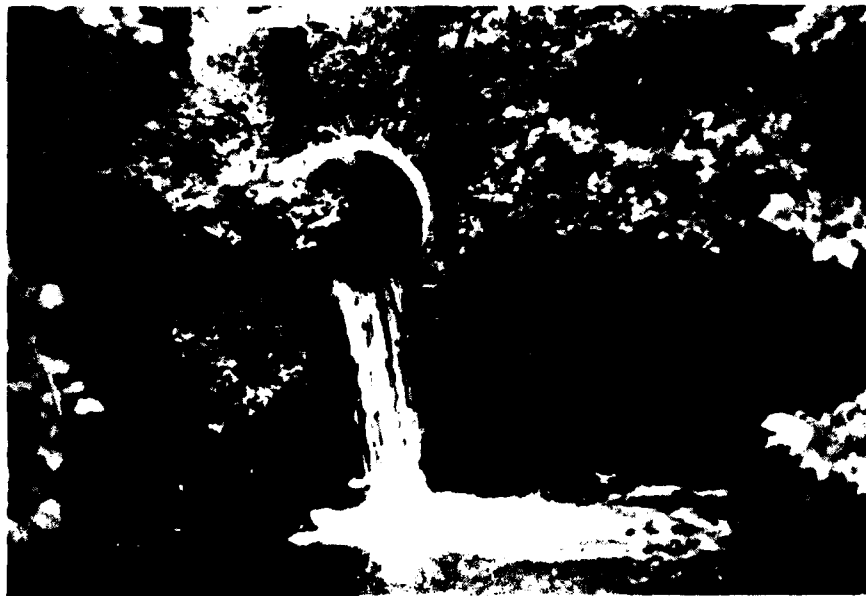
Photograph No. 5 - Outlet Pipe and Plunge Pool

The downstream toe was dry and no seepage was observed. Some iron staining was noted around the plunge pool, but this may be related to spring flow through iron-bearing bedrock. Two 6-inch CMP toe drains exist, one on either side of the principal spillway outlet. There was no flow from the left drain. Flow from the right drain was clear and estimated at 2 gpm<sup>+</sup>.

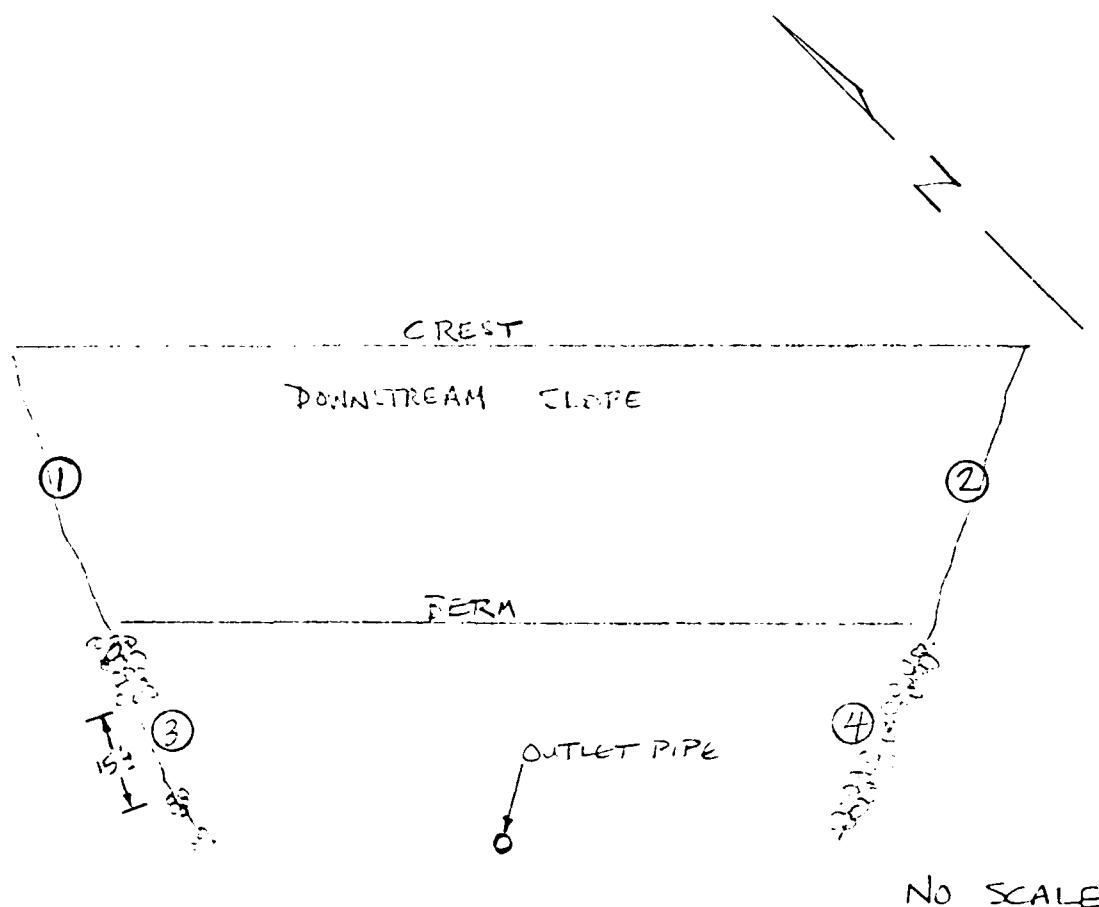
- ① RIGHT DOWNSTREAM ABUTMENT-SLOPE CONTACT IS WELL VEGETATED, NO EROSION NOTED.
- ② LEFT DOWNSTREAM ABUTMENT-SLOPE CONTACT HAS EXPERIENCED SOME EROSION DUE TO SURFACE RUNOFF. INCLUDES SCATTERED EROSIONAL NOTCHES 1-2 FT± WIDE AND 1-2 FT± DEEP. SOME SLOUGHING ALSO NOTED NEAR BERM-ABUTMENT CONTACT.
- ③ DISPLACED RIPRAP OBSERVED BELOW THE BERM ALONG THE RIGHT DOWNSTREAM ABUTMENT-EMBANKMENT CONTACT. HIVE IN UPPER RIPRAP AREA 15 FT± WIDE AND 10 FT± LONG. RIPRAP IS 1-3 FT± LONG. THEN 15 FT± LONG AREA WITH NO RIPRAP. THEN SCATTERED RIPRAP BELOW.
- ④ RIPRAP IS CONTINUOUS IN THIS AREA.

- f) Areas of displaced riprap along the right downstream abutment-slope contact should be monitored during maintenance to detect the development of erosion. If erosion should occur, it is recommended that the missing riprap be replaced.
